PROJECT PORTFOLIO

Aquaduct double contained trench drain with ductile iron grates

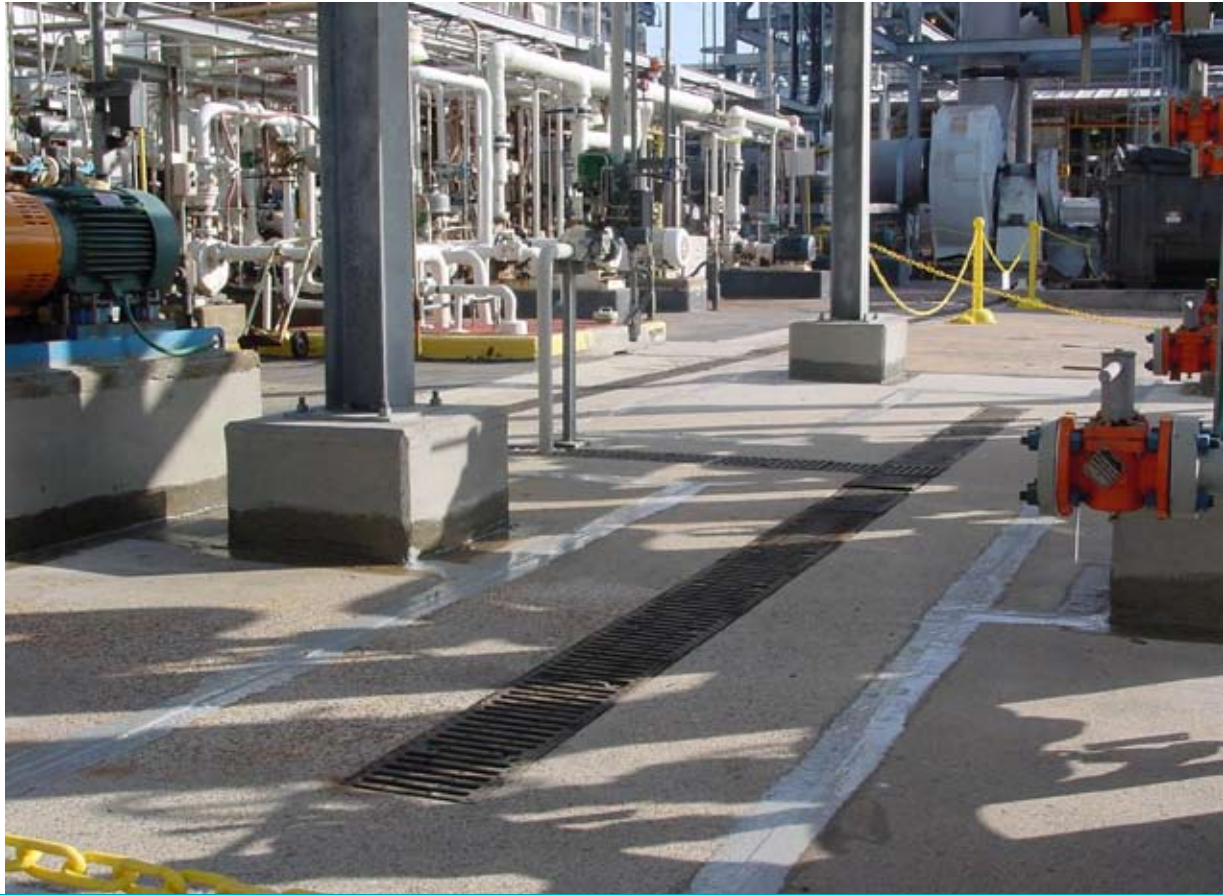
This would provide a primary and secondary trench drain - one inside the other. If the primary trench

failed, liquids would be collected in the secondary trench rather than leach into local groundwater. Visual inspection points at low points enable a view into the secondary channel to check for leaks.

The ductile iron grates offered a heavy duty solution to withstand the maintenance equipment used in the area.
